PD Testing Finds Problems in Turbine Generators & Monitors Repair Effectiveness

Company: Conectiv
Plant: Hay Road
Unit: Unit #4 (115kVA, 104MW)
PD Sensors: Two 80pF couplers installed directionally
Date: June 2001

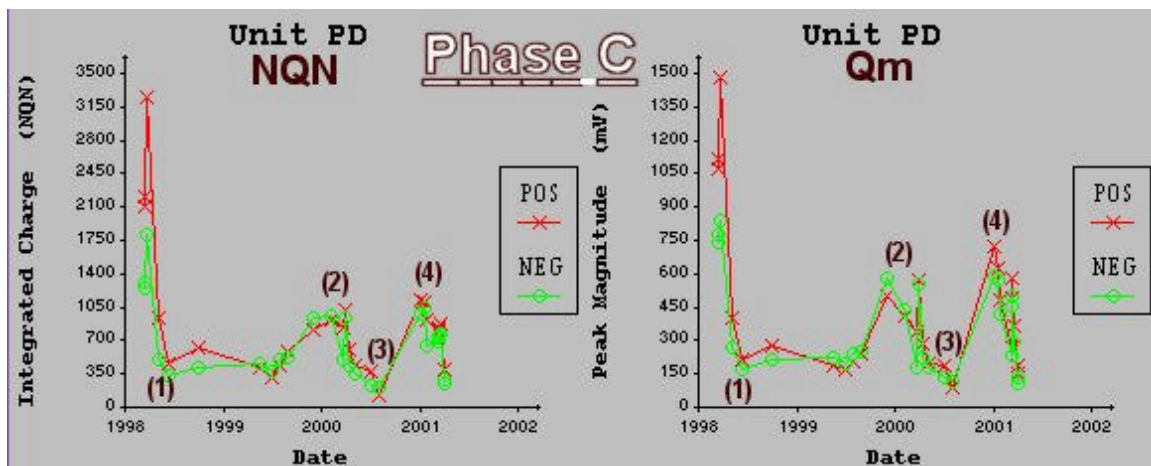
Figure 1: An example of the PD trend for this unit.

On-line PD measurements showed the PD activity remained stable for approximately one and a half years. Then an increase in PD activity on all three phases was experienced. At that time, the PD activity reached an NQN of 1039 and Qm of 579mV – denoted (2) in Figure 1. This compared to the top 25% of similar machines in Iris PD database. The pulse phase analysis is indicative of phase-to-phase dependent discharge activity with negative and positive PD pulses being centered at 15° and 195° phase angle with reference to the phase to ground voltage.

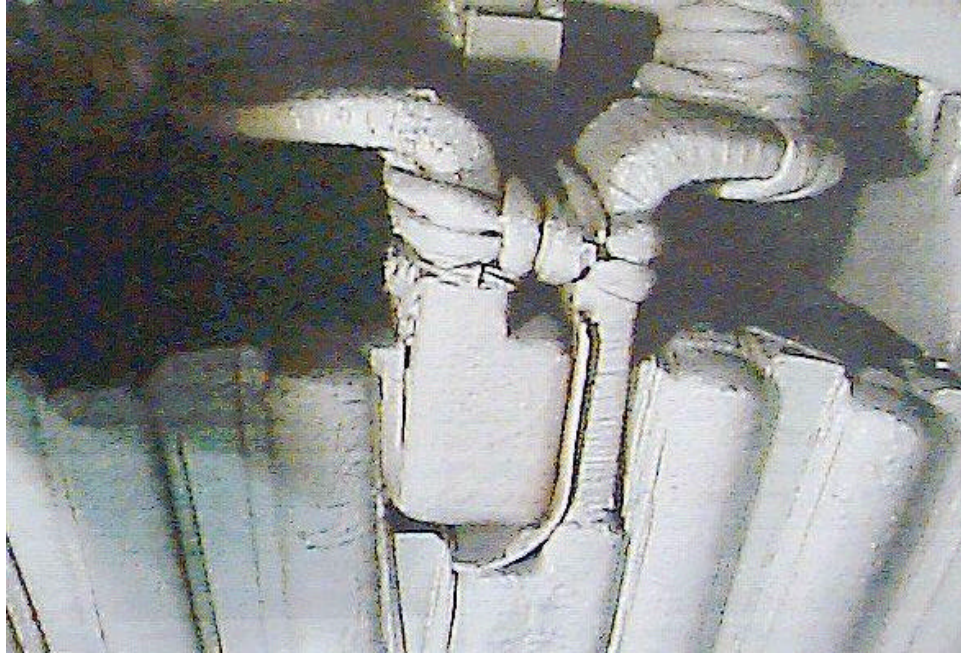
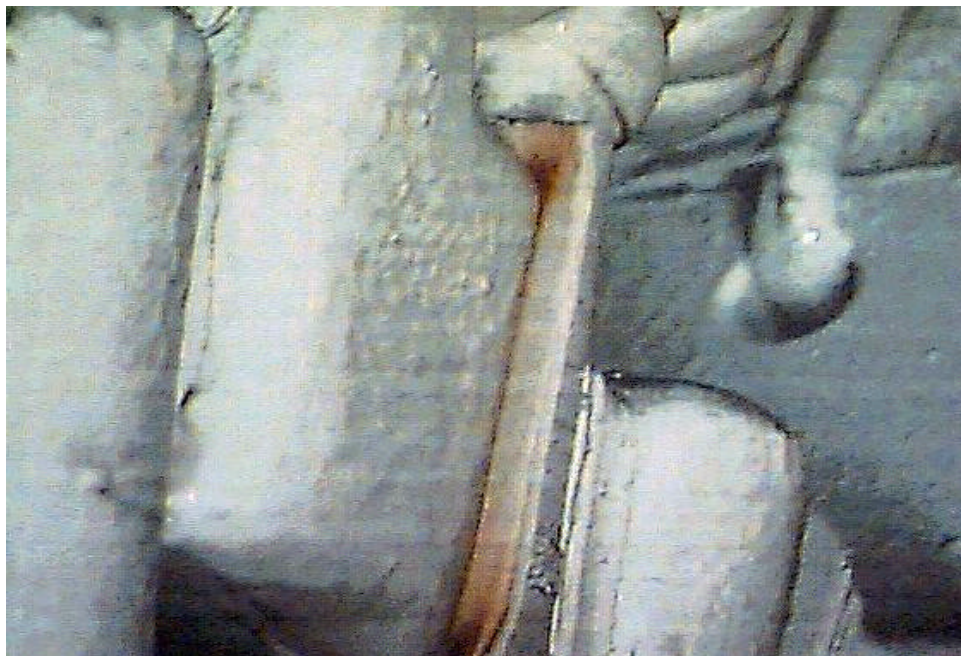
The unit was taken off line and inspected. It was found that all six-phase barriers were burnt and close to a flash over (see photo).

The generator vendor came in and did a temporary repair to the barriers. While working on the unit, the winder stated that he felt without the corrective repair the unit would not have run through the summer.
