POOR AIRGAP IN 3000HP MOTORS IDENTIFIED IN BOILER AIR FAN APPLICATION

Company: Utility in Texas, USA
Ratings: 3000 HP, 4.16 kV, 60 Hz, 1184 rpm, 108 stator slots, 133 rotor slots, 4 motors

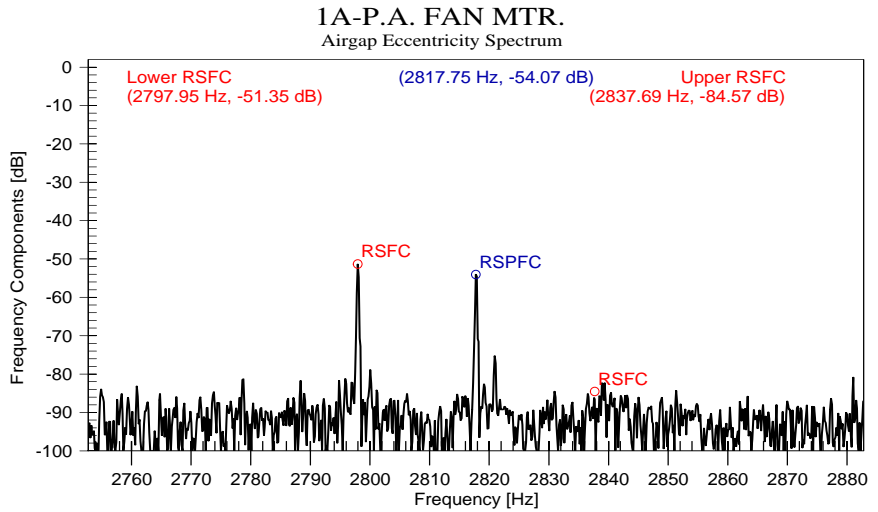
Figure 1. Airgap Eccentricity Spectrum

The Boiler Primary Air Fan motors showed high vibration levels, which appeared to be electro-magnetically induced. In February 2006, the CSMeter was used to perform broken bar and airgap eccentricity (AGE) tests. After about 2 minutes per motor the CSMeter came up with a diagnosis, on its LCD screen, that the rotor windings on all four were healthy, but that the AGE was unacceptable on the three of them. This was confirmed by the current spectra, displayed by the CSMeter. The FIGURE 1 shows the spectrum of one of the motors, with an AGE severity of 13.89 dB (average difference between the RSPFC and RSFC sidebands). A severity of less than 15dB indicates poor AGE. This finding provided guidance to the utility in question as to what type of inspections were required to determine the cause of this problem. The problem was finally corrected, and the vibration was reduced to acceptable levels.
